## Floating House, Worcestershire

### Unusual floating house uses Saniflo to pump waste

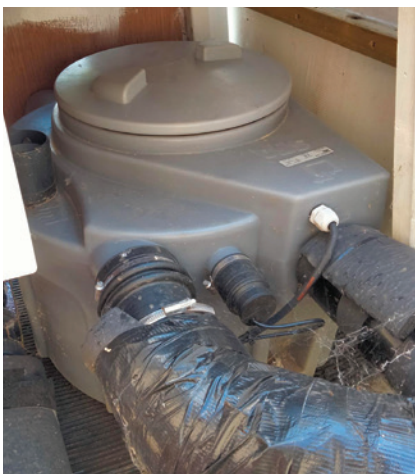
The Saniflos 110 takes the waste from the internal pumps and discharges it through small bore pipework up the hill to the mains drains

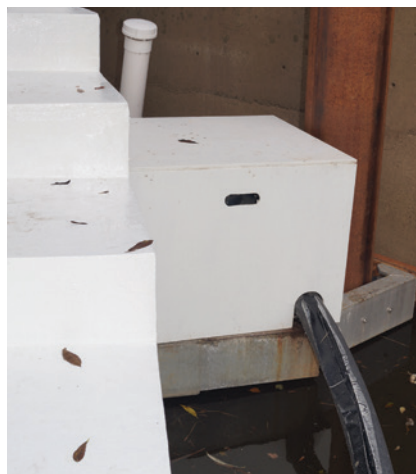
On the Saniflos the vent port had also been blanked off completely. As vents are essential for the correct operation of a pump - displaced air needs to be pushed out when the pump is filling with water - the lack of vent was forcing air back in via the inlet pipe. Inversely, when the pump activates and the water level falls, it needs to draw air so as not to generate a vacuum. The vent port in the tank was opened to fix the immediate issue and an installer from PumpMaster returned later to install a vent pipe and cage. According to Oliver;

The Saniflos 110 is installed in a box adjacent to the house and floats up and down with the house as the tide moves

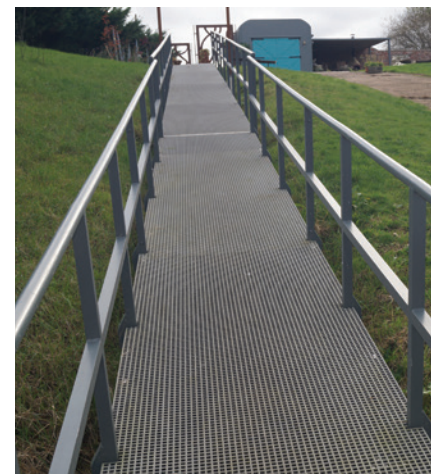
The mains drains are located at the top of the walkway; an incline of 7.5m. The walkway also moves up and down with the rise and fall of the water
